PROJECT DOSSIER

Baden Slide Monitoring Project, USA

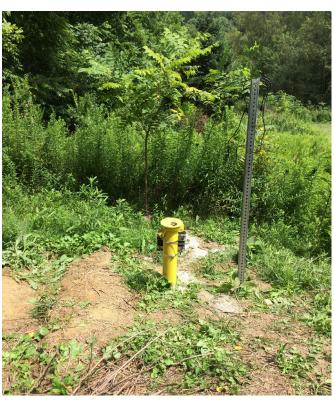
In-place inclinometer installed with datalogger, at the toe of slope

Four model EAN-52M digital in-place inclinometers were used for monitoring - two were placed 60 ft apart at the top, and two were placed 50 ft apart at the toe of the slope. Each system included chain of digital IPI sensors, with 5 ft gage length.

The data from each string of IPIs was collected by model ESDL-30 dataloggers. The datalogger collected the data at required frequency and sent recorded data wirelessly to the cloud server via cellular network.
