# PROJECT DOSSIER

NDRC Horizontal
Directional Drilling
(HDD) works for
132 KV Electrical Cable
Installation

# PROJECT OVERVIEW

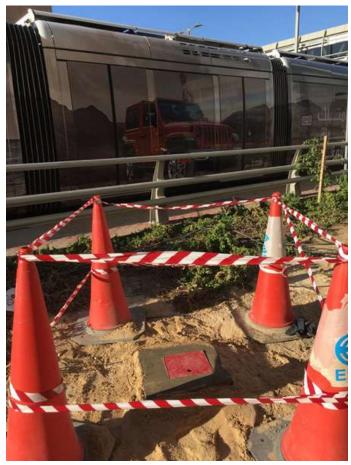
The settlement of the tram tracks was difficult to monitor during tram operation time. We proposed cat-eye prism for vertical settlement monitoring, so we can monitor it without going near to the tram. These are special prism suitable for roads and pavements. The orientation of the prism was decided to have a clear line of sight and also to collect data from one stable location out of zone of influence.
