PROJECT DOSSIER

Seymour Street Office Renovation Project, USA

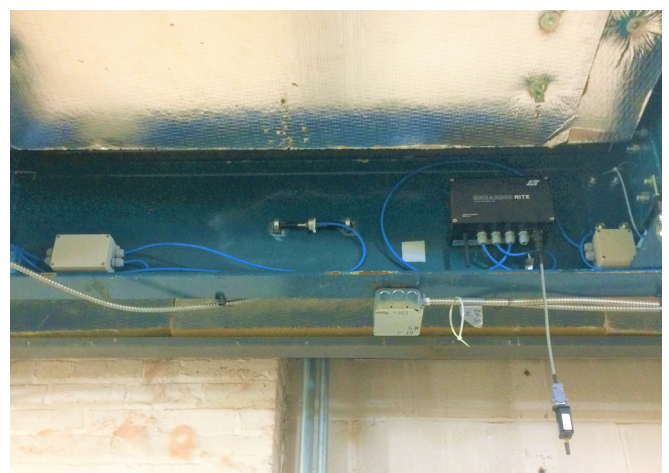
Strain gages installed on W-beam with datalogger

Model EDS-20V-AW arc weldable strain gage were evenly spaced across the second story W-beam, located parallel at the top of the perimeter wall. The data was collected by model ESDL-30 datalogger that transmitted the data wirelessly to central server via cellular network.

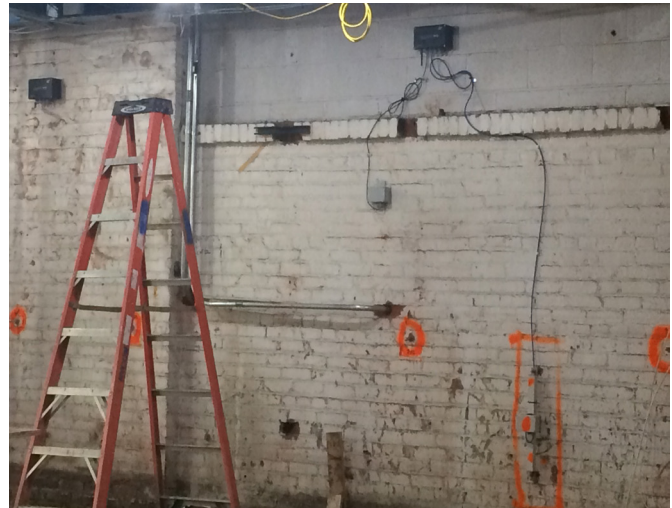
Tilt meter and beam sensor connected to wireless tilt meter with in-built datalogger

Additional digital tilt sensor and beam sensor were used on the structure wall to monitor tilt at different levels. Model EAN-93M tilt meter was installed at center while model EAN-93M-B beam sensor was installed to the lower portion of the perimeter wall. These sensors were connected to model ESDL-30MT wireless tilt meter. The in-built datalogger in ESDL-30MT collected and transmitted data from these digital tilt sensors also.
