## El Espígol Rock Stability Project, Spain

### PROJECT OVERVIEW

Project	El Espígol Rock Stability Monitoring Project
Location	Gerb, Catalonia, Spain
Client	Provincial Council of Lleida
Contractor	Kuroba Quatre SL
Duration	December 2021 - Ongoing (as of Feb 2023)

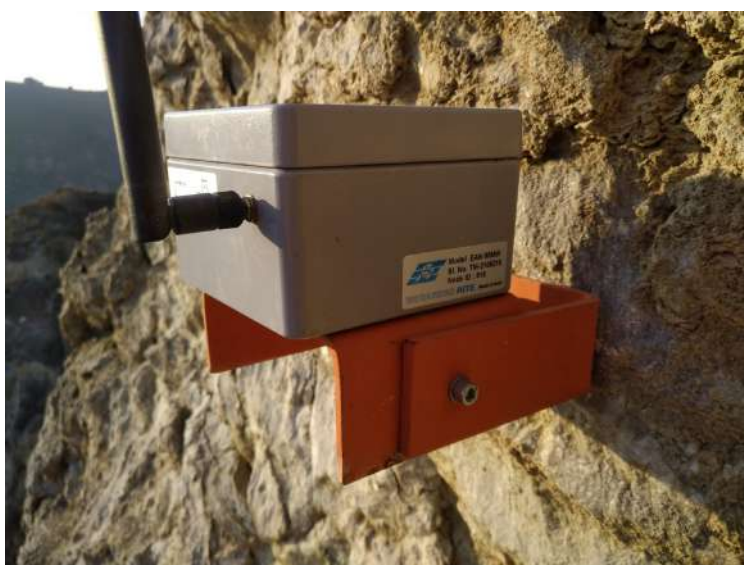
Wireless tilt meter with in-built RF datalogger, installed on the rock

In the first stage, two crack meters and two wireless tilt meters were installed. The crack meters were automated using wireless RF dataloggers (nodes). Wireless tilt meter had in-built RF datalogger.

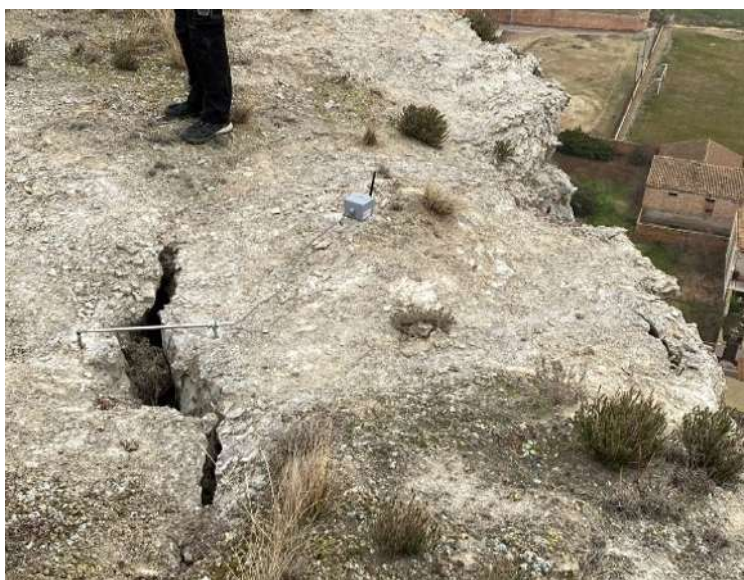
Crack meter installed across the crack on the rock

The idea of initial instrumentation and monitoring plan was to carry out a study over a course of a year. But to the surprise of all, within two weeks the instruments showed movement (December 2021), indicating that the rock was cracking. The installed tilt meters recorded a total tilt variation up to 18 degree, and the crack meters recorded a displacement up to 4.89 mm.

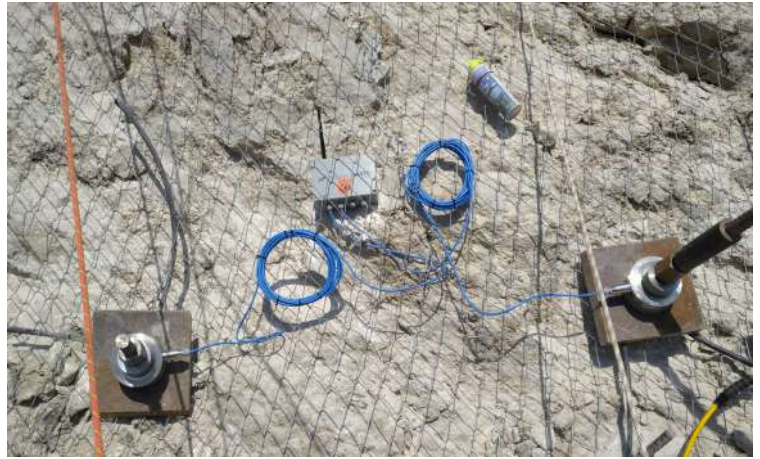
Load cells installed with RF datalogger on the rock bolts installed for the rock stabilization

In the second stage, 4 numbers of anchor load cells and 4 numbers of vibrating wire piezometers were installed in addition to the sensors deployed in the first stage. These were also connected to RF nodes and gateway network.

Looking at the alarming situation, remedial measures were immediately taken. Metal mesh was raised and rock bolts were installed to restrain the rock movements. Extra instrumentation including load cells and piezometer were installed to monitor the rock as well as the stabilization measures taken.

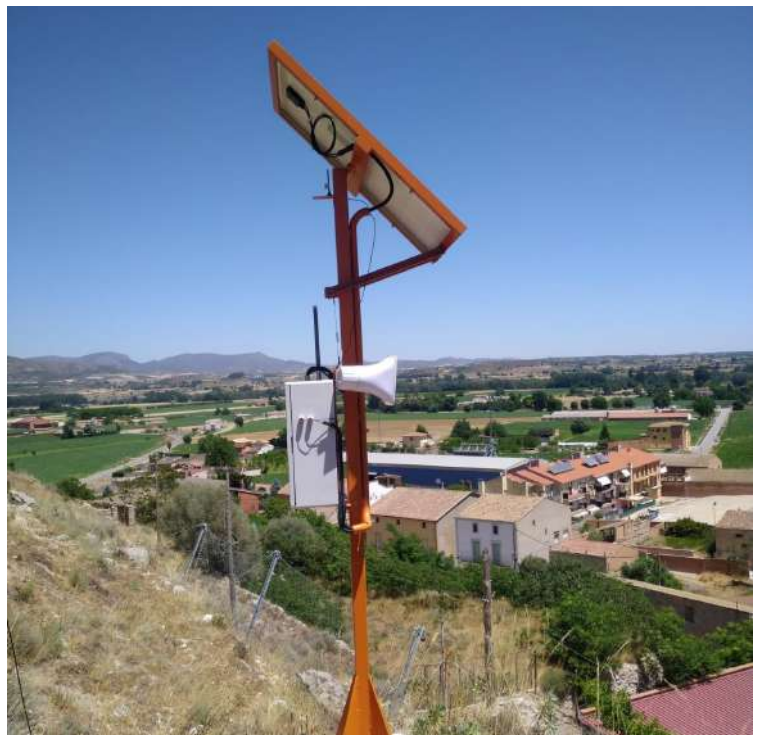
The alarm and siren system installed on the cliff

The acoustic alarm device installed in phase 1 was replaced by a system in which the alarm was activated directly from the Data Management System.

This improved system allowed alarm to be triggered in case data of any of the installed sensors crossed alarm limit. This avoided being dependent of a single sensor located in a specific point. The alarm system was equipped with a siren.
