Project dossier

PROJECT OVERVIEW

Herron Hill Reservoir is a secondary drinking water reservoir constructed in 1880 and located in the City of Pittsburgh, Allegheny County, Pennsylvania. A steep slope surrounds the reservoir. Upgrades to the drinking water treatment facility adjacent to the reservoir required construction of a retaining wall excavated into the base of the slope.

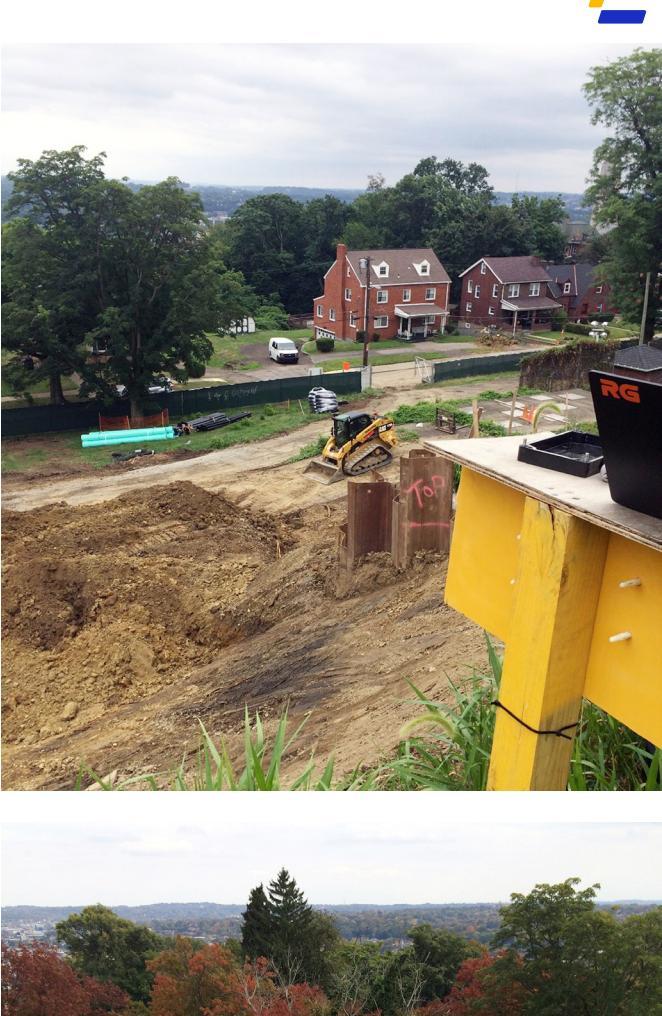
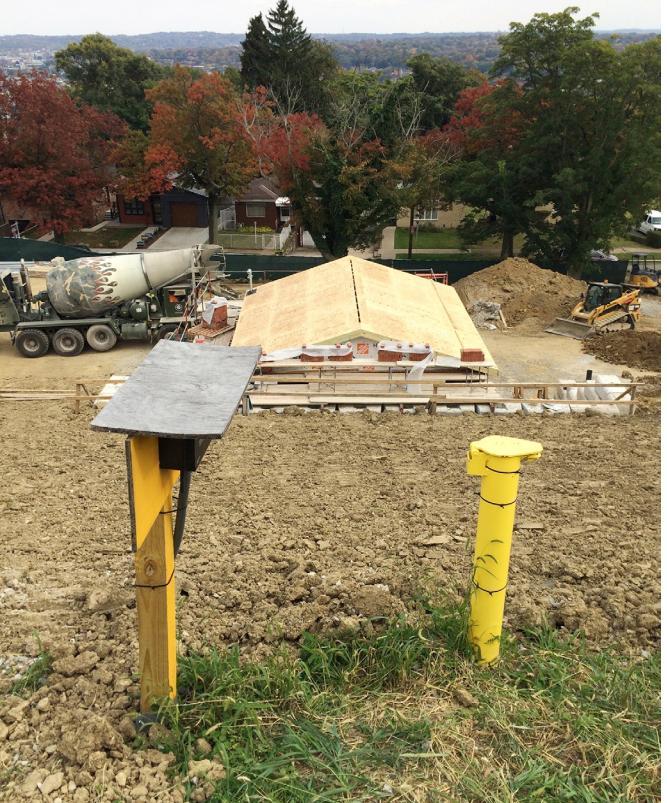
In-place inclinometer installed at site with wireless datalogger

Model EAN-52M in-place inclinometer system was used to monitor sub-surface lateral movement. It was installed in a 30 ft deep borehole at the top of the slope behind the retaining wall. The IPI consisted of a chain of digital IPI sensors, with 5 ft gage length.

The data from the IPI chain/sensors was collected by model ESDL-30 compact datalogger. The datalogger trasmitted the recorded data wirelessly to the cloud server via cellular network.
